# BUAYANYUP RIVER ACTION PLAN

Prepared for the Geographe Catchment Council (GeoCatch)

*By Gemma Mincherton | December 2010*

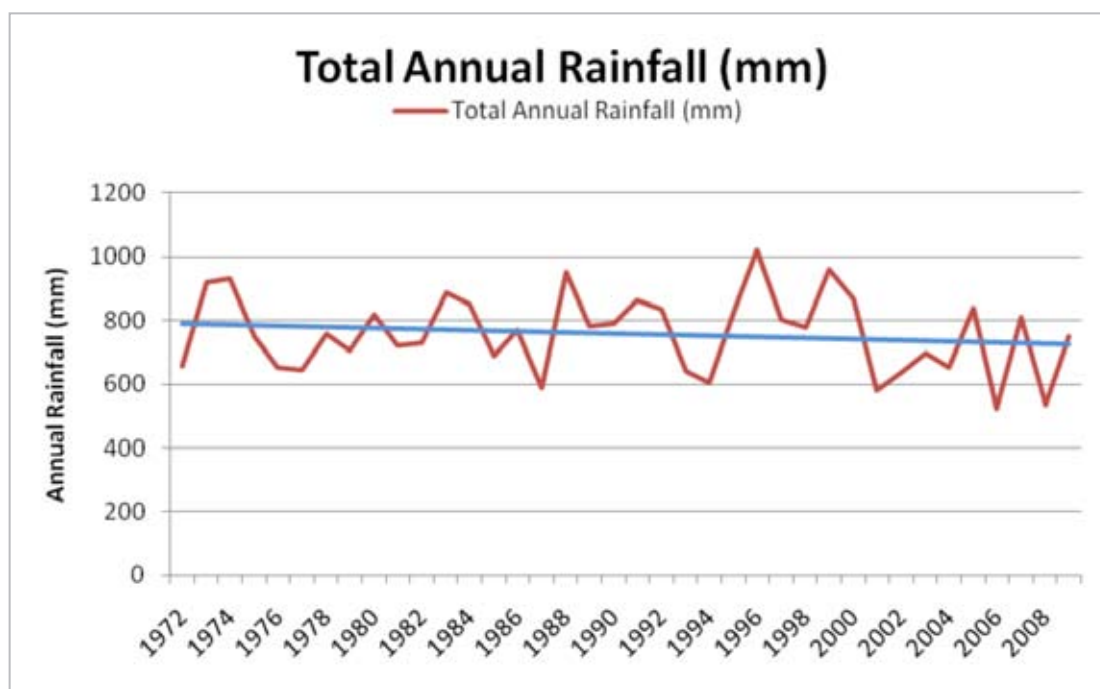
**Figure 2** Annual rainfall recorded in Chapman Hill from 1972 to 2009

The region has already been affected by climate change, experiencing a 10 to 15% decrease in annual rainfall since about 1975 which has resulted in runoff decreasing to less than half the earlier levels. The decline in autumn and early winter rainfall and a reduction in rainfall intensities is most marked. Climate modelling predicts that the climate in the South West region will become hotter and drier by 2030. Figure 2 below shows the total annual rainfall recorded from 1972 to 2009 just outside the Buayanyup catchment in Chapman Hill.

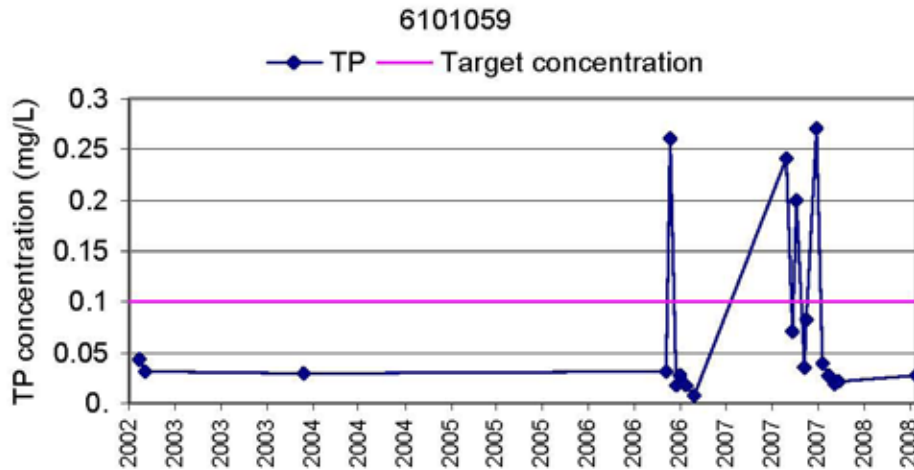
**Figure 7** Levels of total phosphorus in the Buayanyup catchment 2002 to 2008

The winter median concentration for total nitrogen (TN) for the Buayanyup catchment is 2.05 mg/L which is classified as 'very high', and 0.04 mg/L for total phosphorus (TP), which is classified as 'moderate' (based on figures in *the Vasse Wonnerup wetlands and Geographe Bay water quality improvement plan*). The following graphs show the monitoring results since 2002 for total phosphorus and 1998 for total nitrogen.

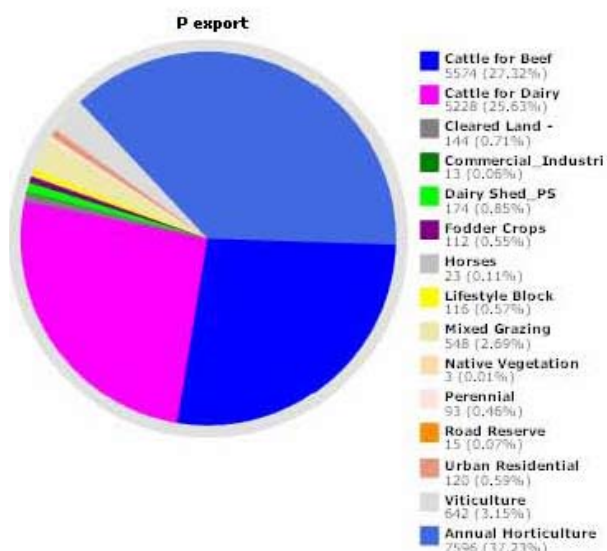
**Figure 9** Pie chart showing land uses contributing to total phosphorus in the Buayanyup catchment

Nutrient modelling undertaken by the Department of Water was used to determine the sources of nutrients in the waterways. As Figures 9 and 10 show, the largest sources of both phosphorus and nitrogen in this catchment are dairy farms, followed by horticulture and then beef cattle farms. Nutrient loads into the waterway are also predicted to increase due to the expansion of the Vasse Newtown urban development. Department of Water modelling suggests that phosphorus and nitrogen may increase by 40% and 10% respectively, primarily as a result of urban expansion (Hall 2009), although these predicted increases may be reduced by the implementation of water sensitive urban design in future developments.

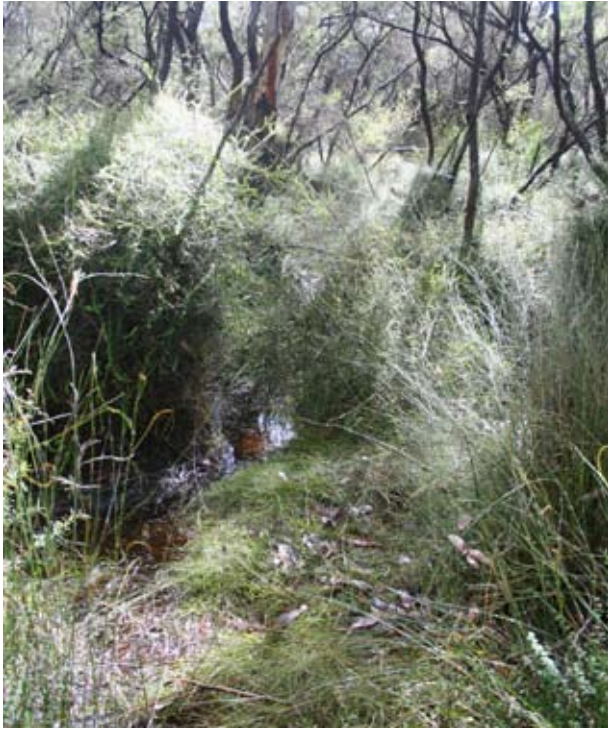
**Photo 1**     *A2 grade foreshore*

A2 grade foreshore is near pristine with a few weeds. Riparian vegetation like this is as good as will be found today.

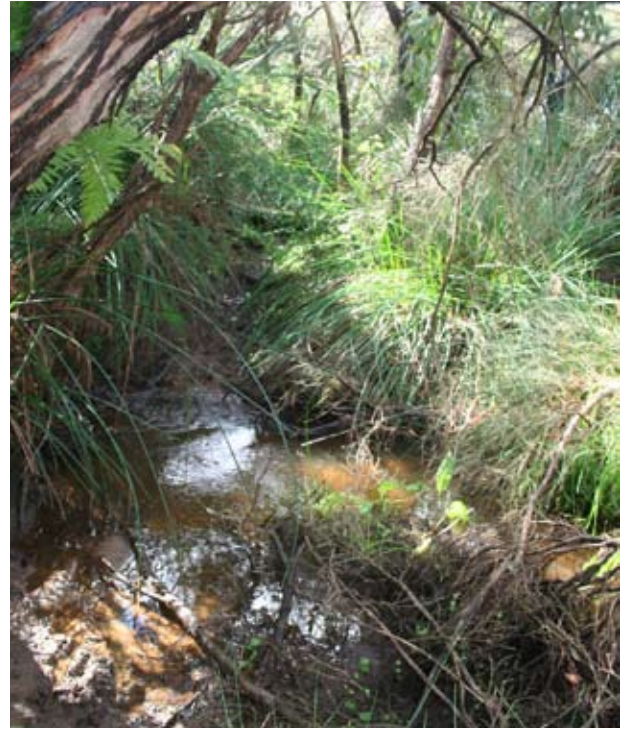
**Photo 2**     *A3 grade foreshore*

A3 grade foreshore shows the native vegetation is slightly disturbed with some dense patches of weeds.

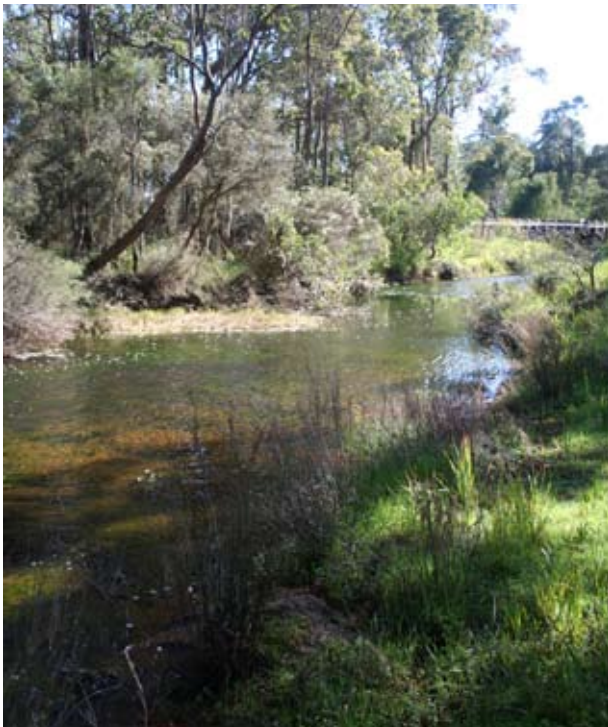
**Photo 3**     *B1 grade foreshore*

B1 grade foreshore shows some of the natives in the understory have been displaced by weeds.

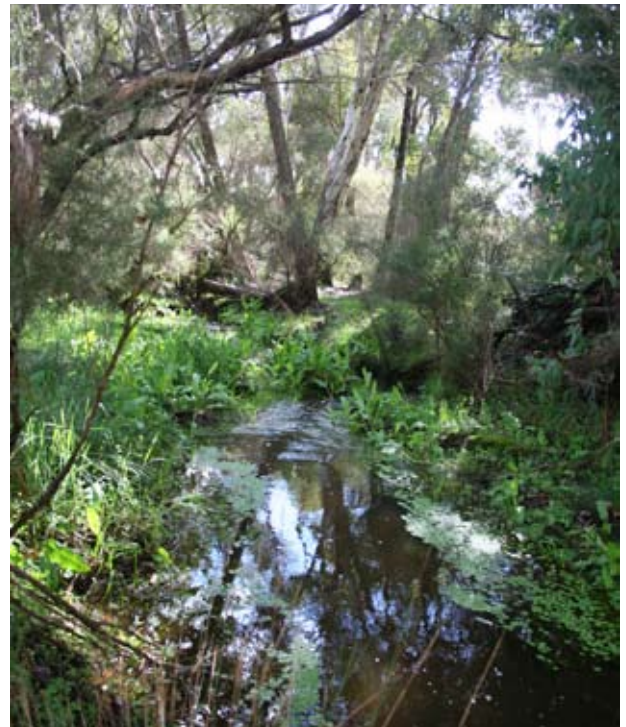
**Photo 4**     *B2 grade foreshore*

B2 grade foreshore shows heavy weed infestations in the understory.

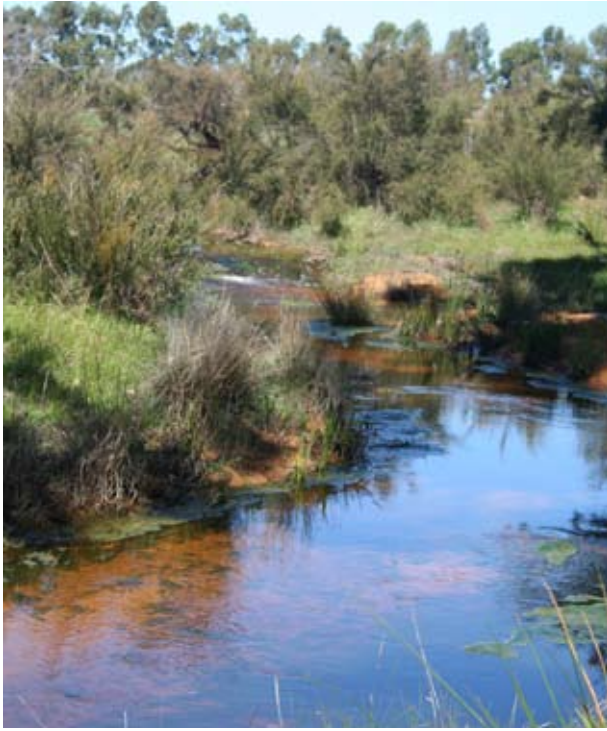
**Photo 5** *B3 grade foreshore*

B3 grade foreshore shows a weed dominated understory with some decline in the trees and shrubs that may have once been present.

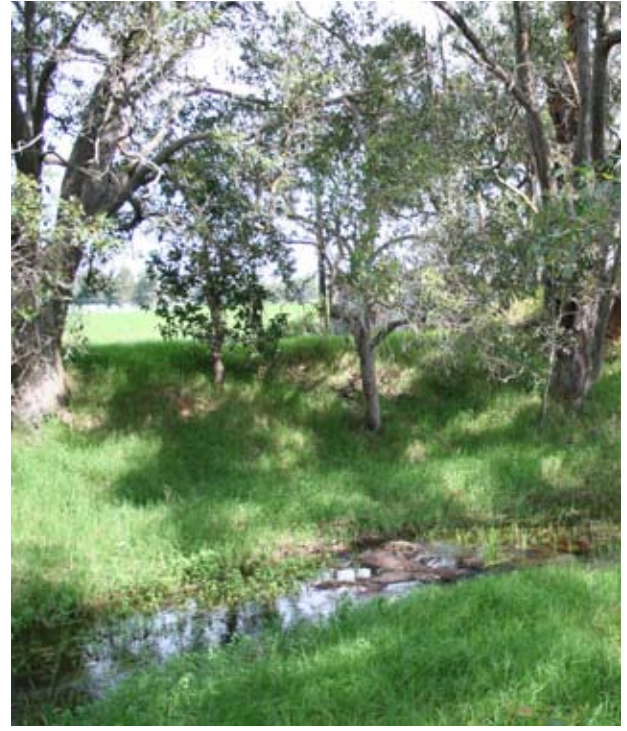
**Photo 6** *C1 grade foreshore*

C1 grade foreshore shows some trees and shrubs remain, but the understory is shallow rooted and erosion prone.

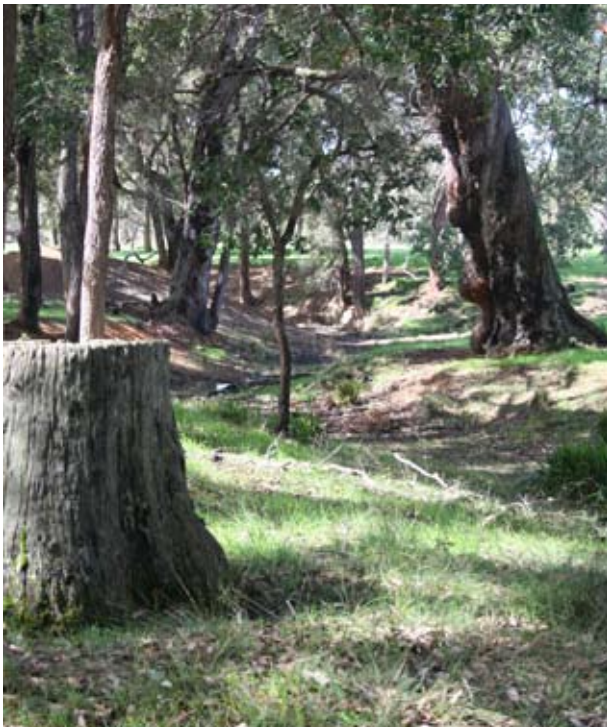
**Photo 7** *C2 grade foreshore*

C2 grade foreshore shows the older trees remaining, but the ground bare from livestock trampling.

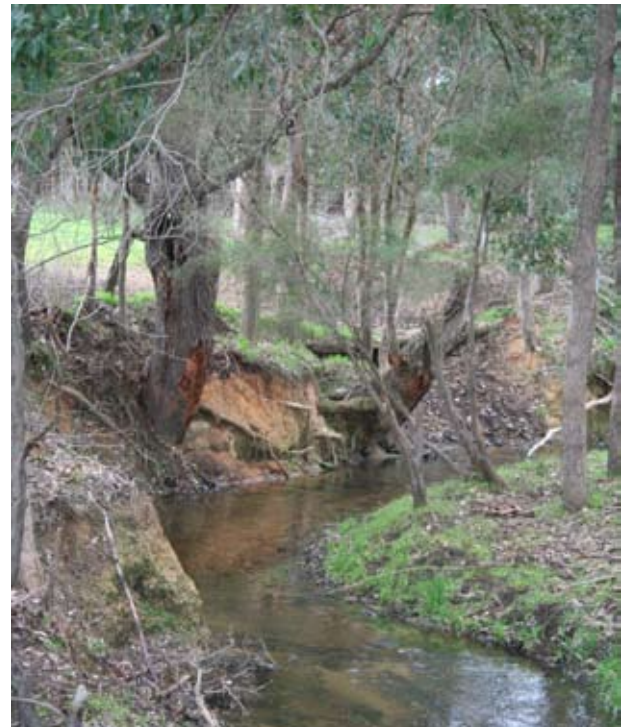
**Photo 8** *C3 grade foreshore*

C3 grade foreshore shows the banks are being undermined by erosion.

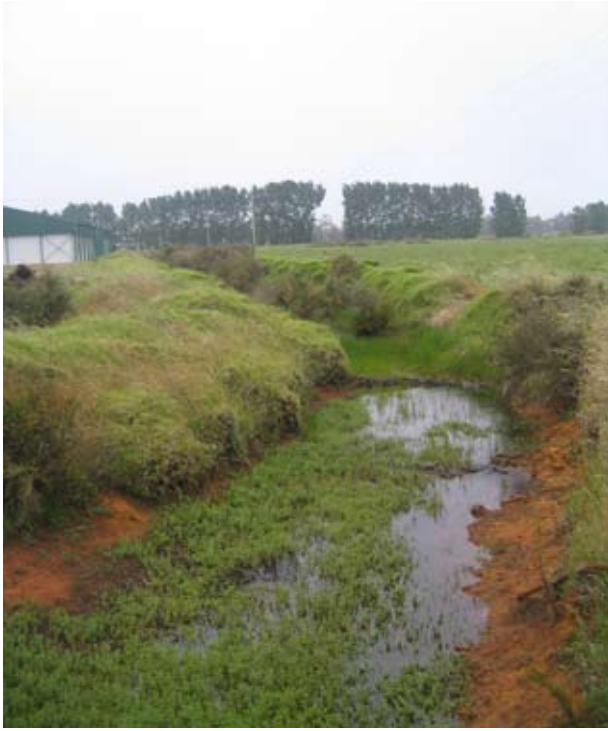
**Photo 9** *D1 grade foreshore*

D1 grade foreshore shows a ditch with some vegetation keeping parts of the bank stable.

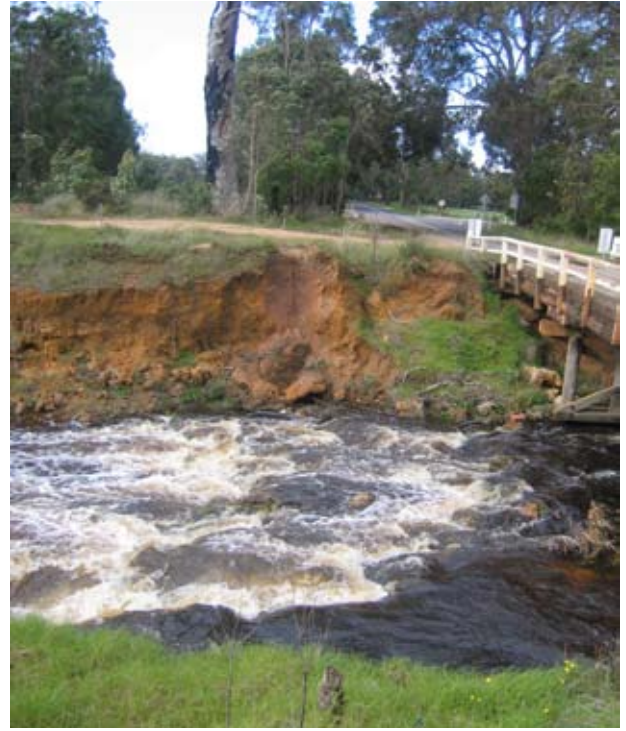
**Photo 10** *D2 grade foreshore*

D2 grade foreshore shows a freely eroding ditch.

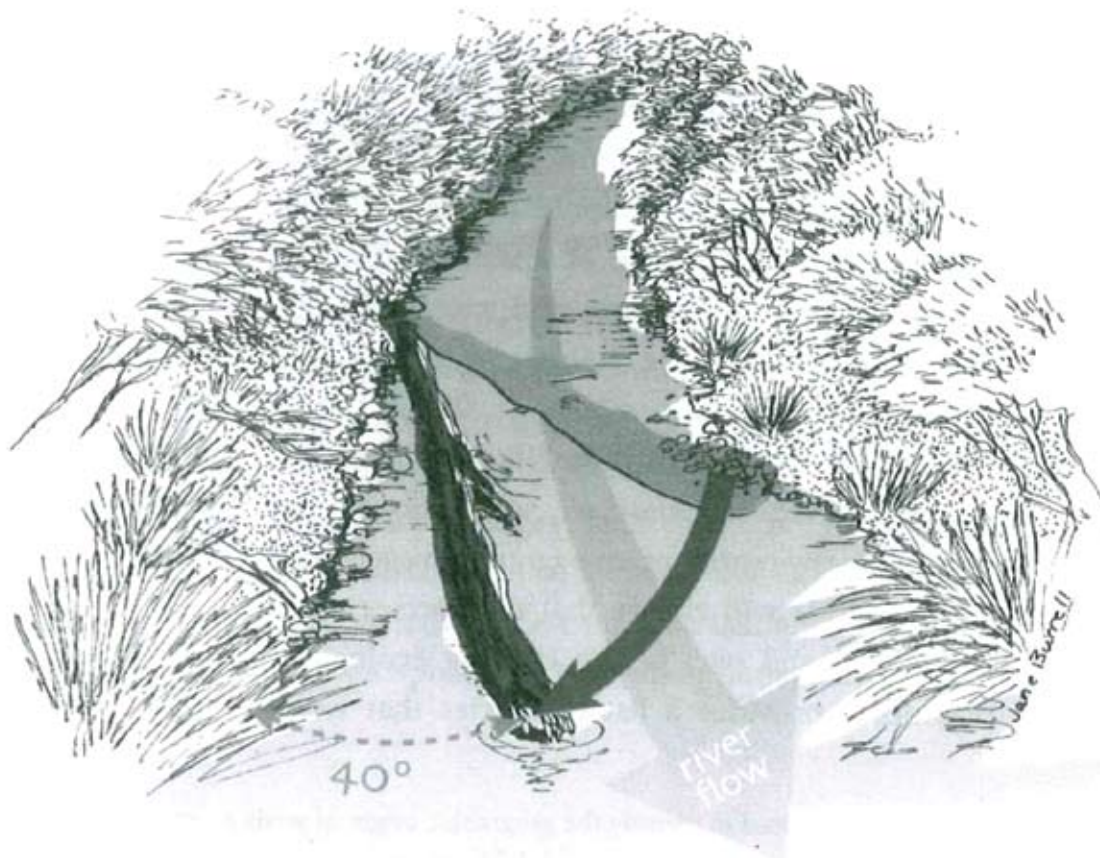
Snags, or large woody debris, are a natural component of the river system. They play an important role in river ecology by providing a range of flow conditions within the channel and habitat for aquatic life forms. Occasionally snags can divert the flow onto the bank and subsequently cause erosion in areas lacking support from native vegetation. While de-snagging rivers has been a common practice in the past, the current management emphasis is to leave as much woody debris as possible. Rather than removing large woody debris from the channel, it should be repositioned at an angle of 20° to 40° to the waterway bank (see Figure 31 (Grippel et al. 1998)). This action will minimise the effect of the snag on flow levels and direction, whilst maintaining the habitat available for plants and animals that benefit from low flow conditions. Large woody debris can also be added to deflect flows from unstable areas.

**Figure 31** *Repositioning large woody debris*
