# River Action Plan for the Cape Naturaliste Streams

Jingarmup Brook, Meelup Brook,  
Dolugup Brook, Dandatup Brook  
and Dugulup Brook

Prepared for the Geographe Catchment Council

Kirrily White, trading as Naturaliste Environmental Services

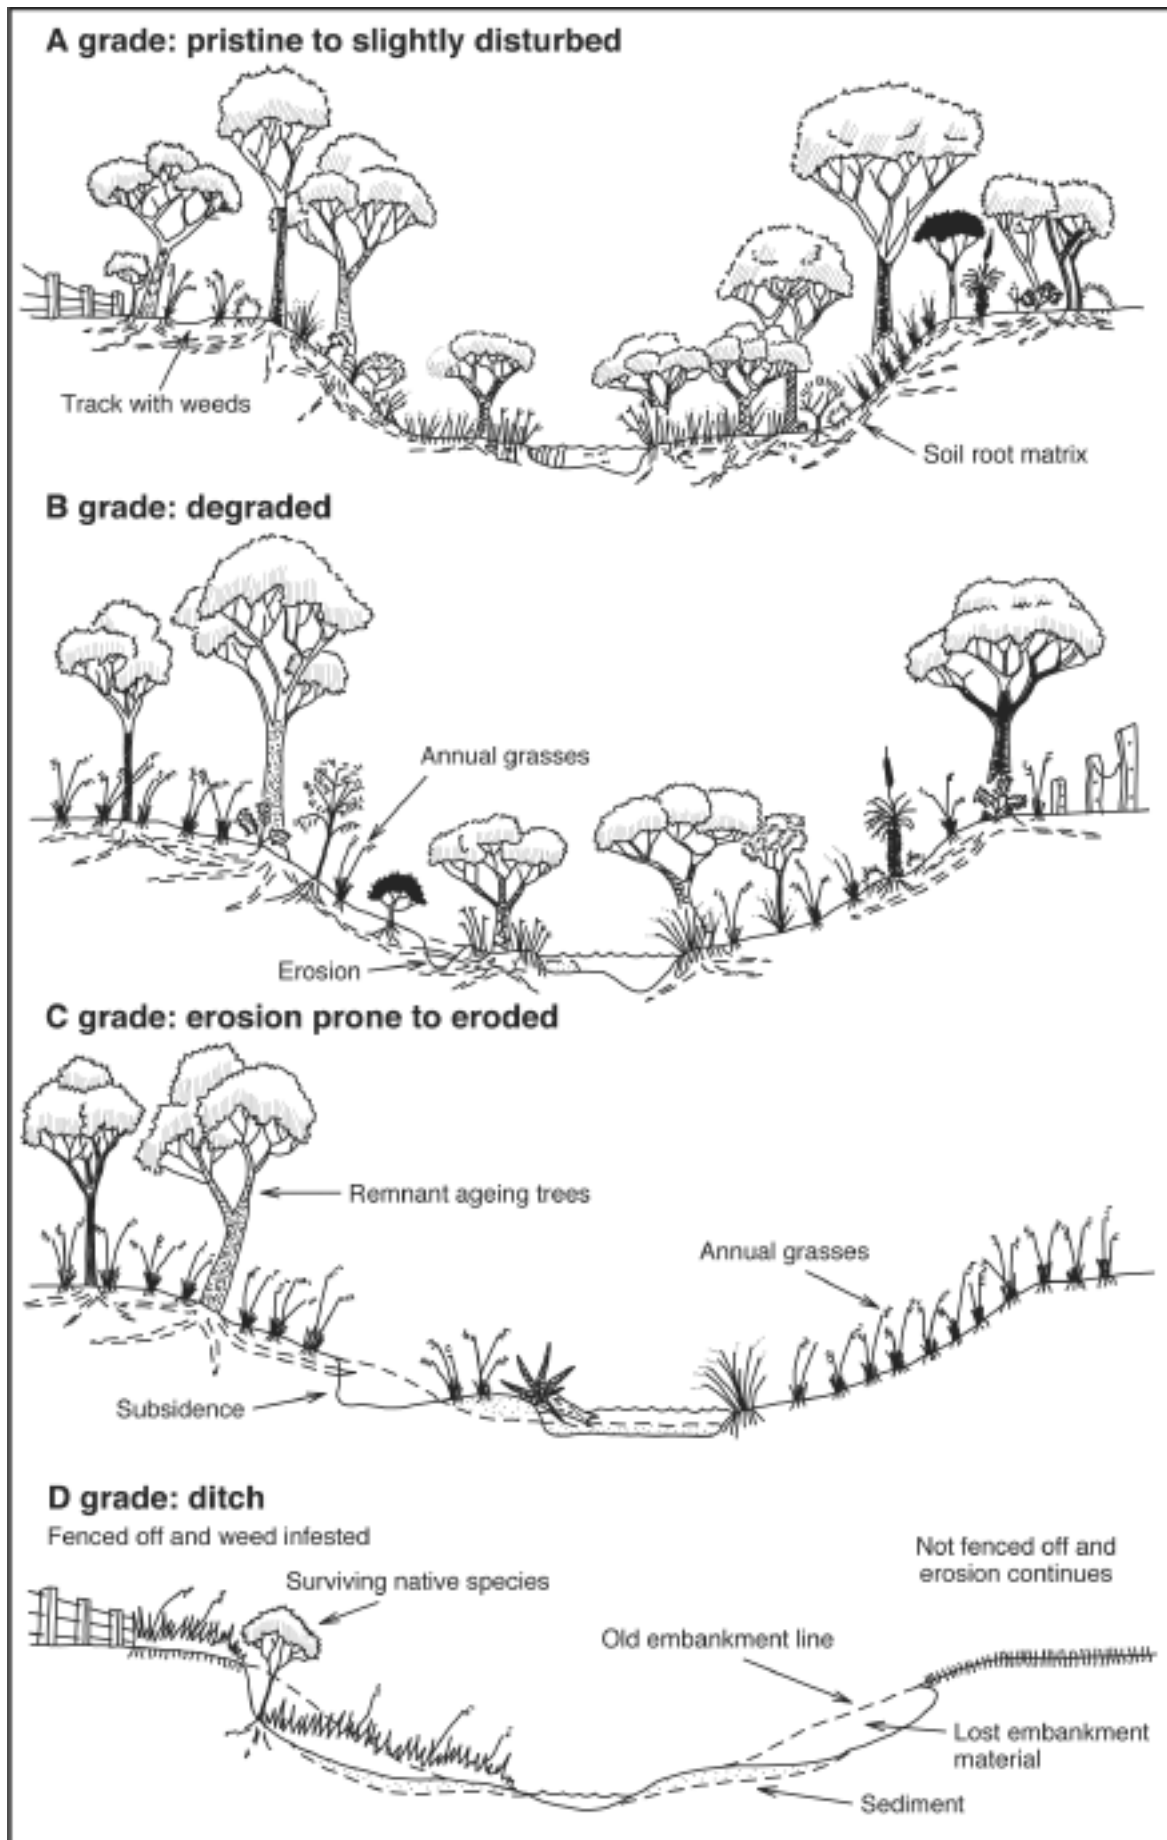
Figure 3: The four grades of river foreshore condition - (A) pristine to ditch (D).

The river embankments and/or channel are entirely vegetated with native species and there is no evidence of human presence or livestock damage. This category, if it exists at all, would be found only in the middle of large conservation reserves where the impact of human activities has been negligible.

Native vegetation dominates but introduced weeds are occasionally present in the understorey, though not to the extent that they displace native species. Otherwise there is no human impact. A river valley in this condition is about as good as can be found today.

In this stage, weeds have become a significant component of the understorey vegetation. Although native species remain dominant, a few have probably been replaced or are being replaced by weeds.

Here, the annual grasses and weeds have been removed through heavy livestock damage and grazing, or other impacts such as recreational activities. Low level soil erosion has begun, by the action of either wind or water.

The highly eroded river valley may have been fenced off enabling colonisation by perennial weeds. The river has become a simple drain, similar if not identical to the typical major urban drain.

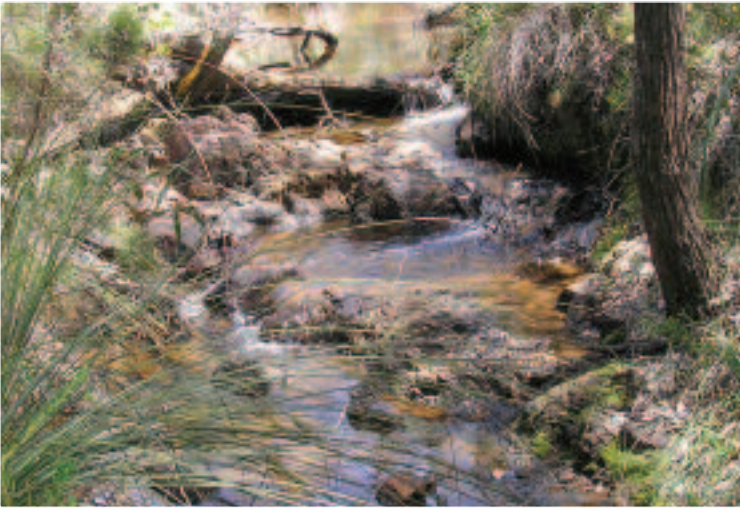
A) A1 – A2 grade foreshore on the Meelup Brook within Meelup Regional Park showing all of habitat zones in tact and undisturbed (Photo by Don Hanran-Smith).

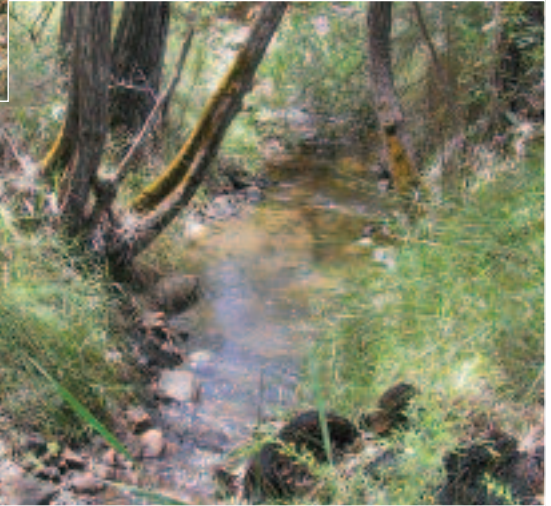
B) A2 Grade foreshore on the Meelup Brook. Fringing vegetation provides back support, shade and leaf litter while a riffle oxygenates the water (Photo by Don Hanran-Smith).

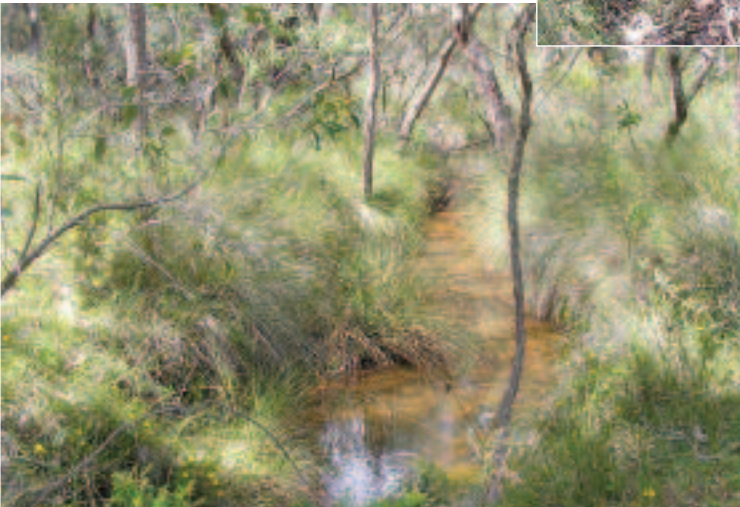
C) A Grade foreshore on the Dandatup Brook. Rushes and sedges provide important bank support and there is a wide band of adjoining healthy vegetation.

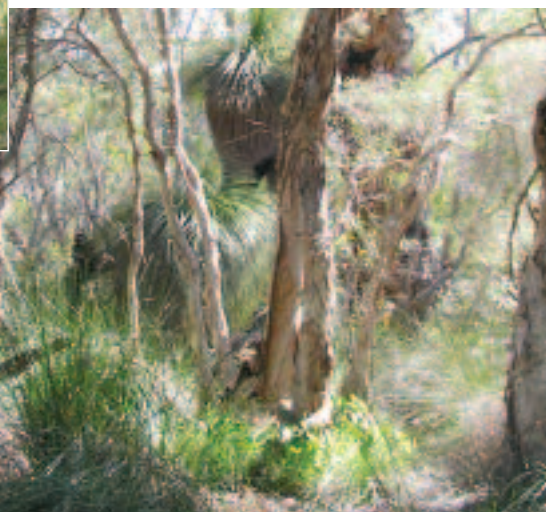
D) B1 Foreshore on the Dandatup Brook. The Melaleucas and native rushes and sedges remain dominant but arum lilies have invaded the understorey.

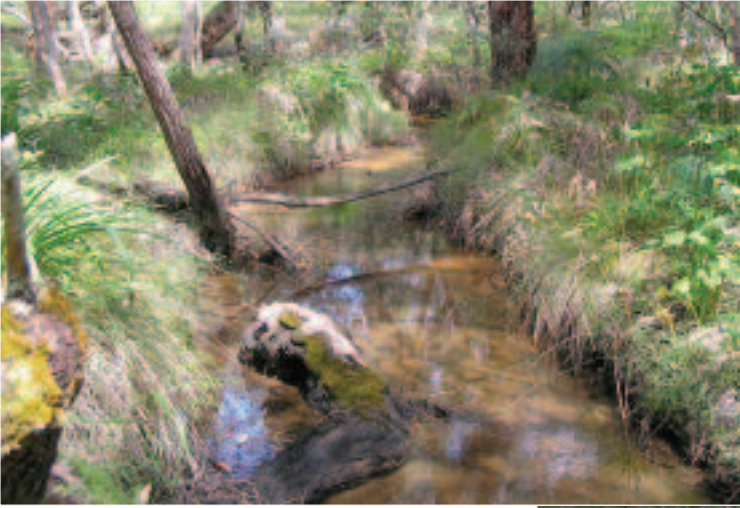
E) B2 – B3 Foreshore on the Dandatup Brook.  
Weeds dominate the understory.

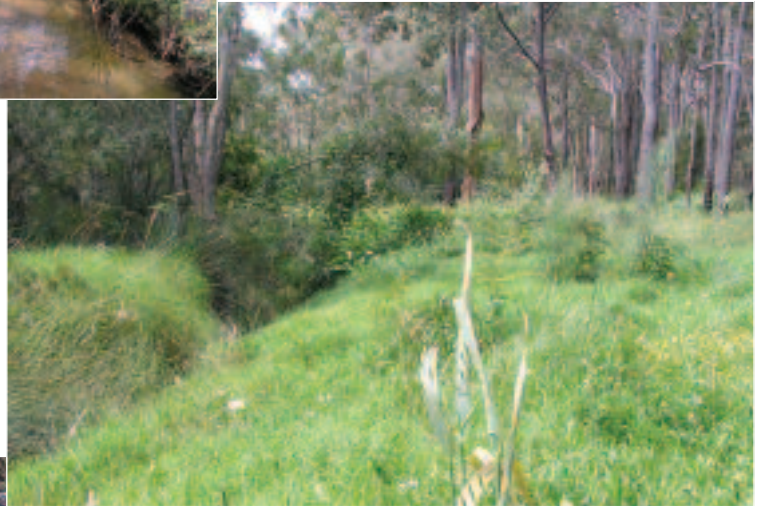
F) C1 Foreshore on the Dugulup Brook.  
Grasses dominate the foreshore and while there are a few trees, there is no sign of regeneration.

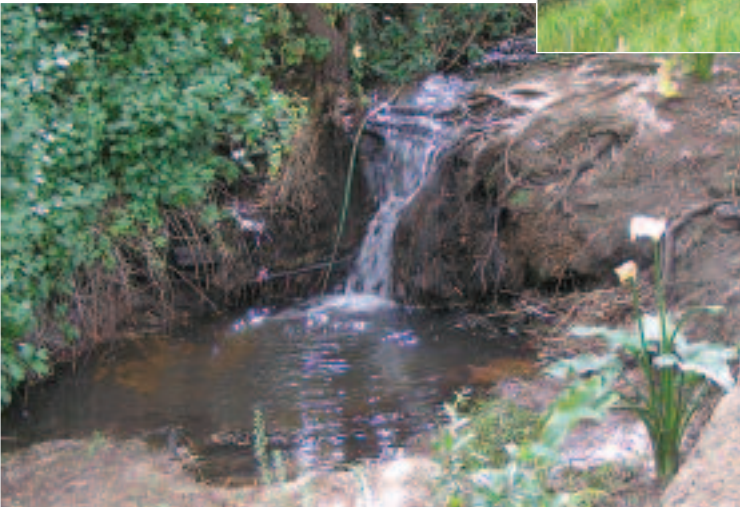
G) C2 Grade foreshore on the Dugulup Brook.  
There are very few native species and soil is exposed. The processes of erosion have commenced.

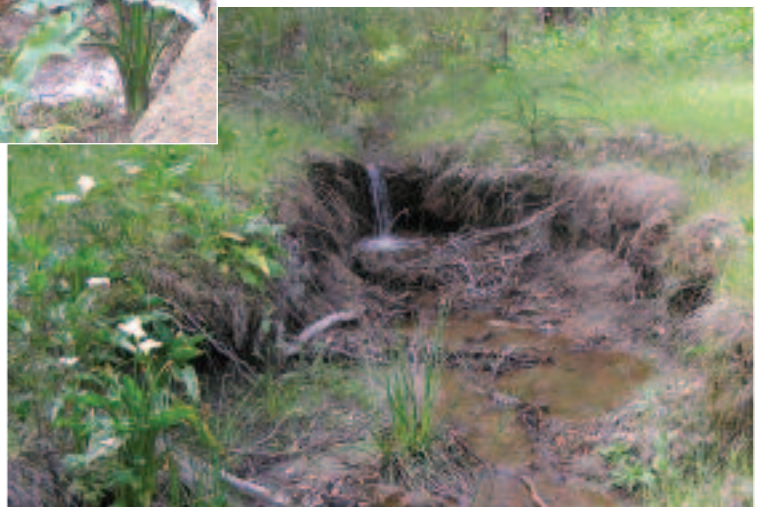
H) C3 grade foreshore on the Dandatup Brook.  
Native vegetation is absent and erosion is active with a head shown here migrating upstream.

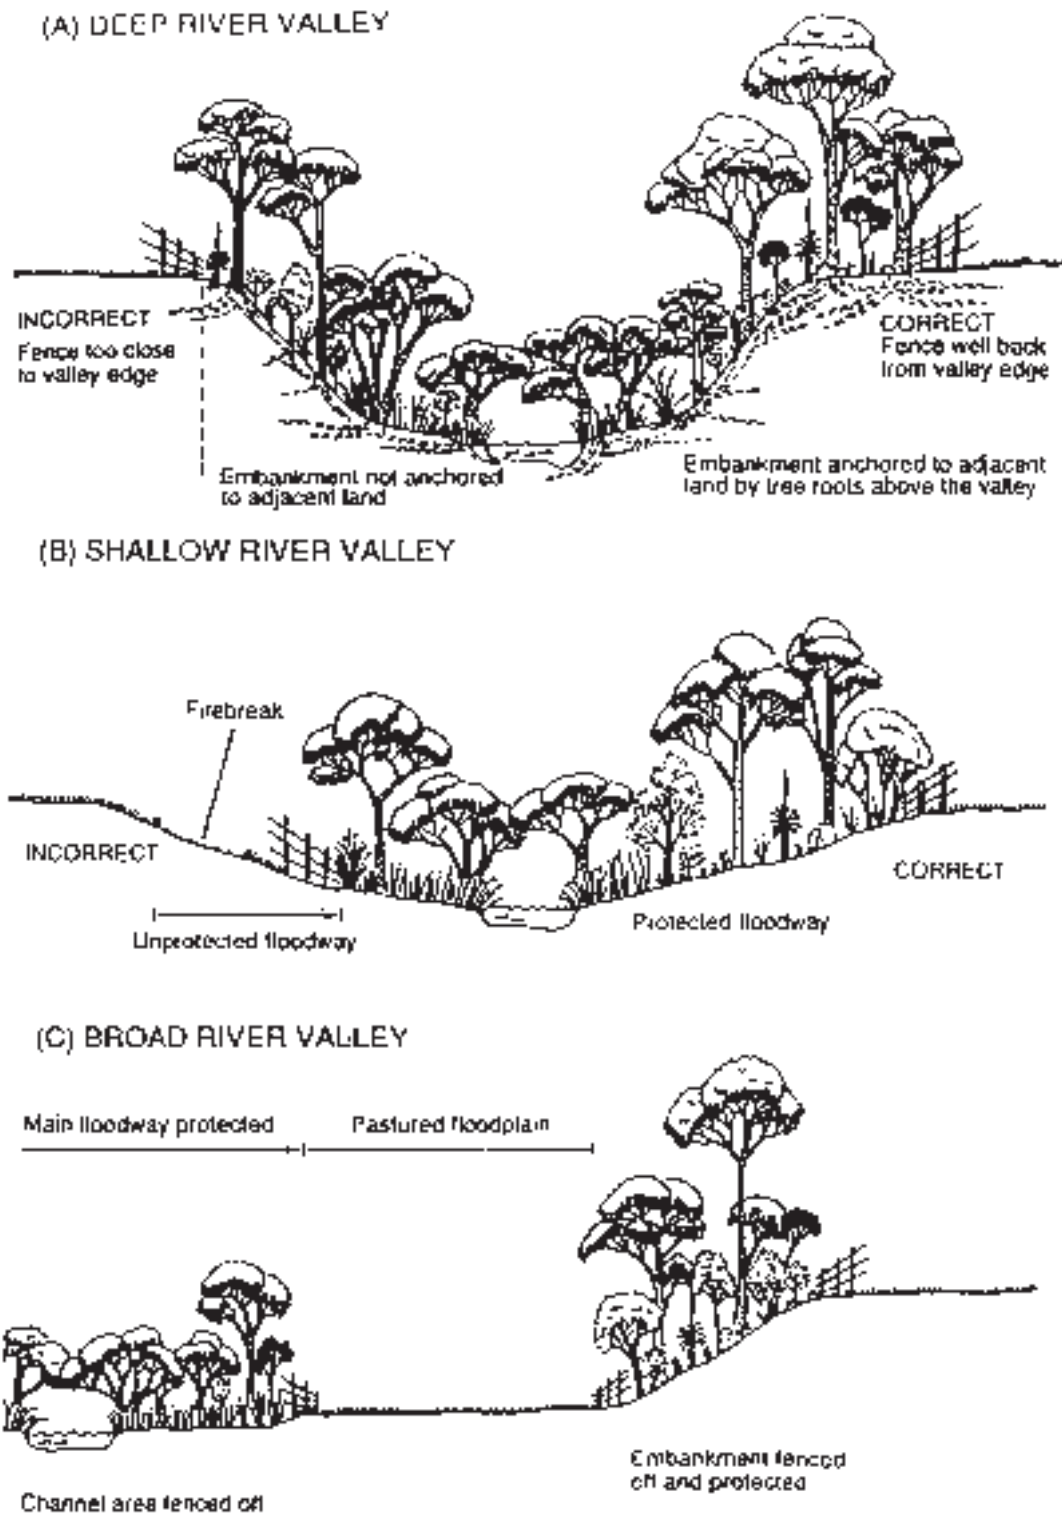
Figure 4: The correct placement of fences in relation to the river valley: (A) the deep river valley, (B) the shallow river valley and (C) the broad river valley with broad floodplain (APACE Green Skills & Pen, 1995).

In the flatter and broader valleys it may be acceptable to use fences to control the level of grazing rather than to exclude it altogether. A careful watch would need to be kept to ensure that the grazing is sustainable and is not so heavy as to prevent the regeneration of native trees, shrubs and sedges.'

Fencing may be used to exclude stock entirely from the stream foreshore, or to allow restricted grazing. Once native species have regenerated or been re-established it may be appropriate to allow careful grazing for short periods to control weeds. Grazing may also be used to control weeds prior to planting. Heavy grazing that would degrade the riparian zone and ultimately eliminate native plant species should be avoided. Total

exclusion of stock will be necessary where the bank is steep and sandy, or prone to collapse, or where the objective is to maintain high quality riparian habitat. A longterm weed management and revegetation plan needs to be developed prior to fencing off riparian land.

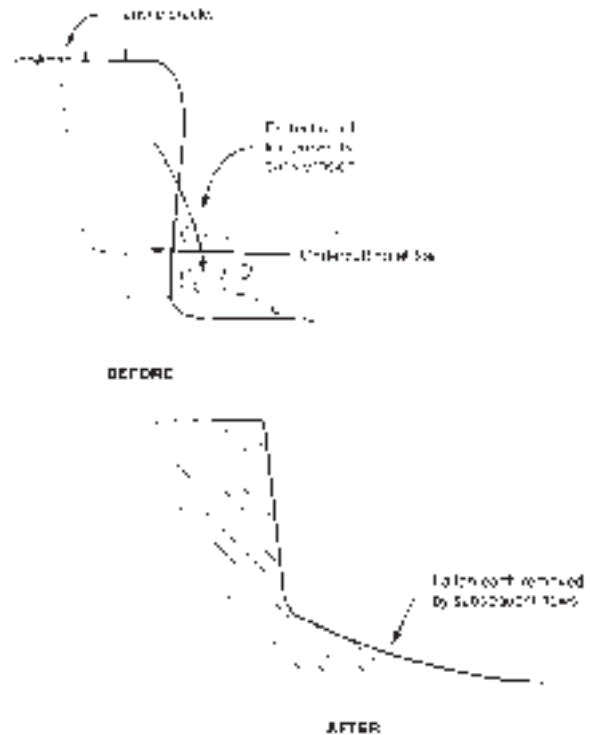
Figure 6: The use of structural works, such as a rock toe, will prevent the process of undercutting (adapted from Raine & Gardiner, 1995).

Undercutting often occurs in conjunction with the formation of point bars. Material is scoured from the toe of the bank, resulting in loss of bank support; this often results in subsidence as illustrated in Figure 6 (Raine & Gardiner, 1995). Previous experience has shown that supporting and protecting the toe of the bank can prevent undercutting. Generally undercutting will occur where there is a meander. If this is the case, only the outside bends need to be supported as the flow velocity on the inside bend is much lower. Once an outside bend is stabilised, the corresponding inside bend will usually adjust its width to cater for the change in flow.

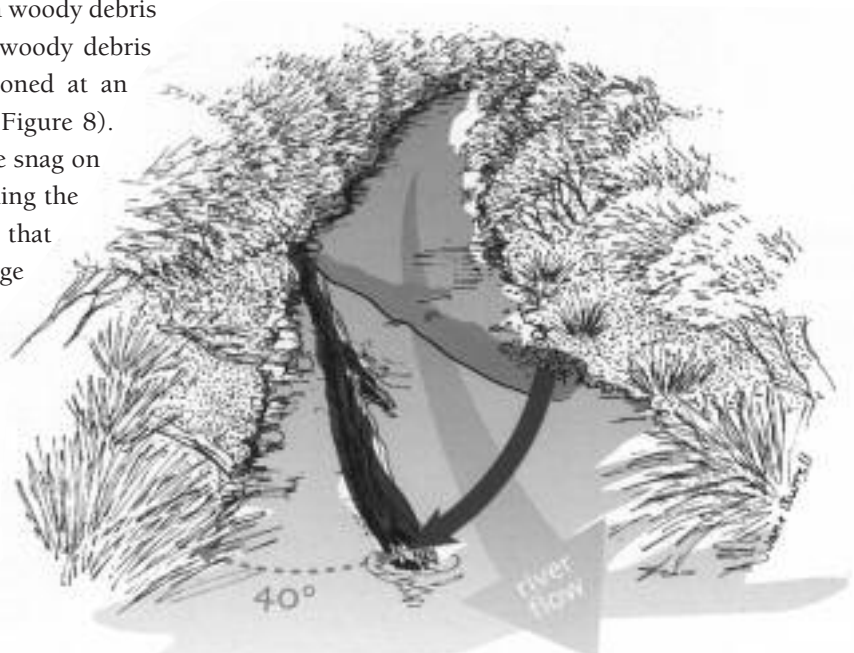
Figure 8: Repositioning large woody debris (Gippel et al., 1998).

**Repositioning LWD**  
 The capacity of a river channel can be improved by rotating the LWD at an angle of 20° – 40° to the streambank.

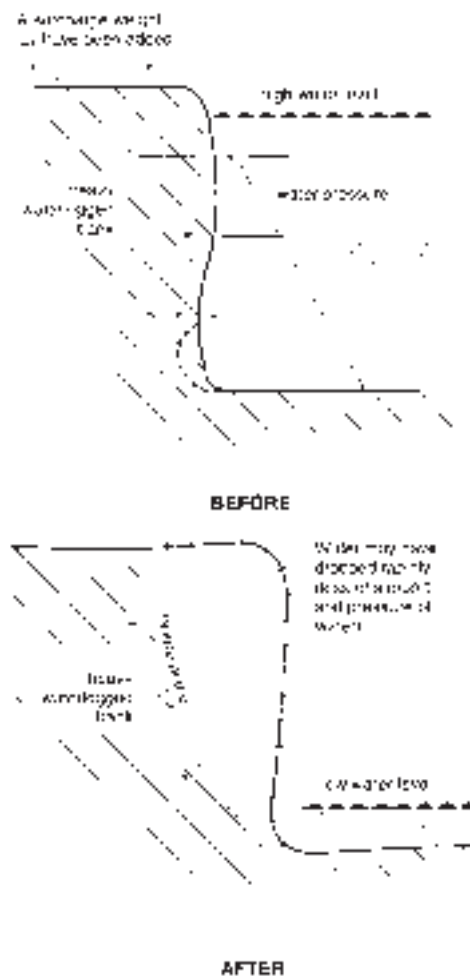
Figure 7: The process of bank slumping caused by excessive weight and lack of support (adapted from Raine & Gardiner, 1995).
